LOGAN CONDOMINIUMS: COMBINING ROOFING AND WATERPROOFING

SYSTEMS

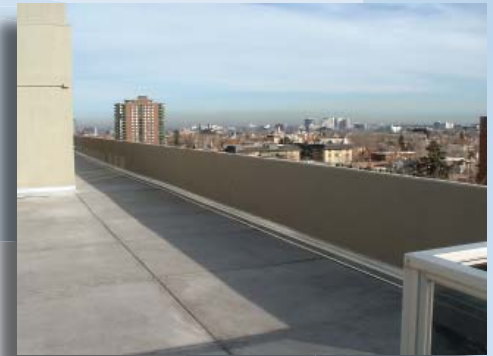
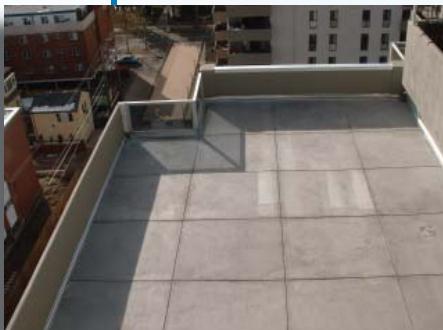
Concrete placed over Drain Matt System

Once the new Carlisle system was in place, the Owner was able to install a new concrete patio deck that will provide years of enjoyment for the buildings occupants. The final project is now ready to take on Colorado's weather extremes.
